## Appendix A: Inspection Photographs

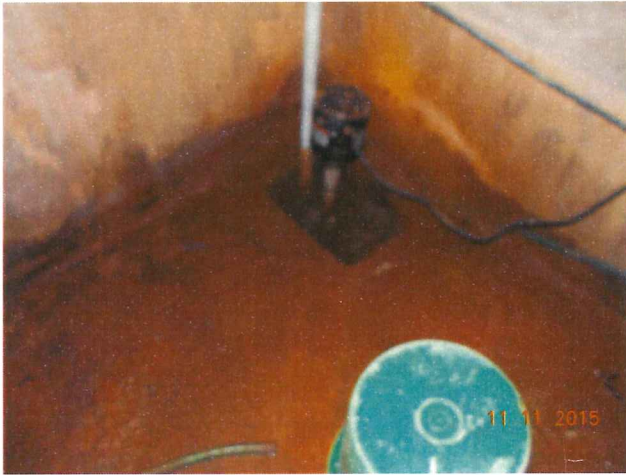
Stagnant water within basement and existing sump pump condition. Pump works, but requires manual activation as the sump ballcock is not attached.

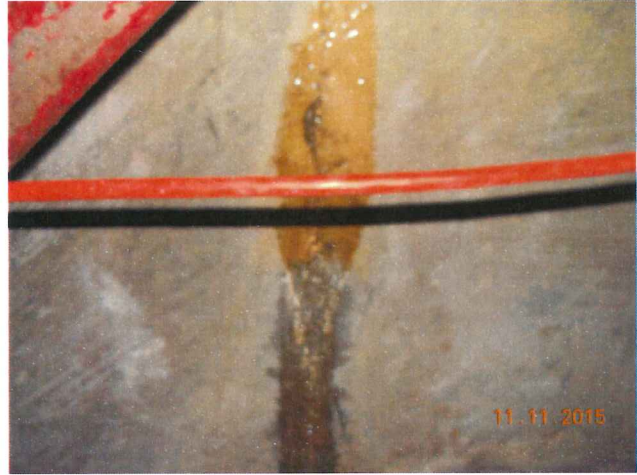
Fracture in right wall of basement stairwell. Apparent leak and infiltration of sump pump water through wall crack. Leaking water re-enters basement down basement stairs.

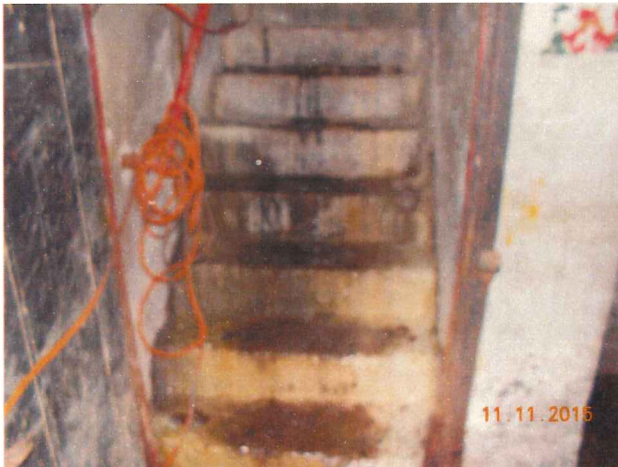
Leaking water coming down stairwell in basement. Salt and grime buildup.

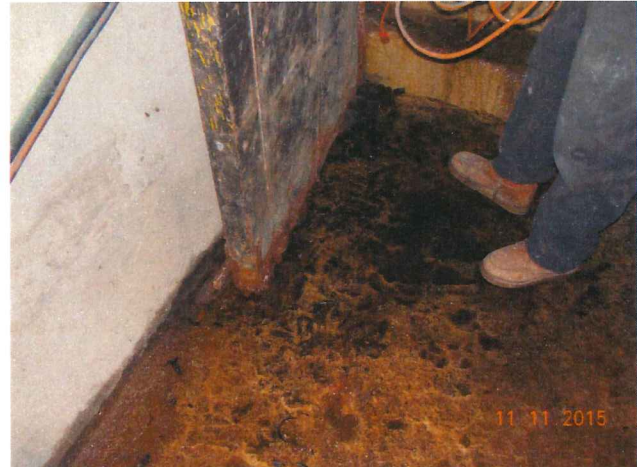
Water collection point at base of stairs. Drains toward sump pit.

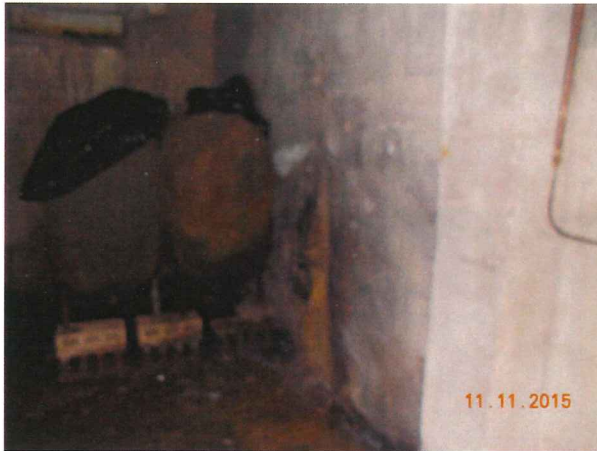
Two existing ASTs in corner of basement room.

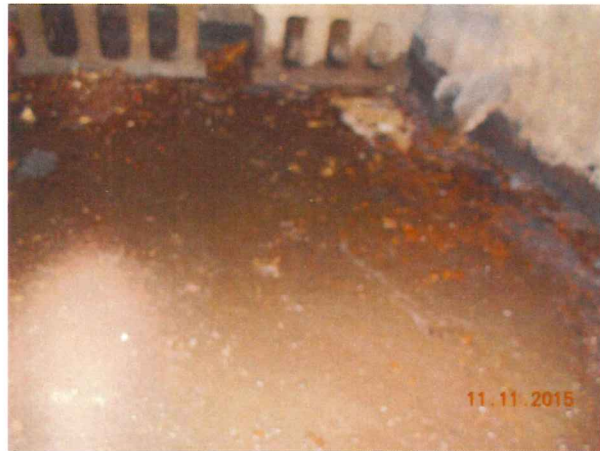
Floor area beneath ASTs. No evidence of oil sheen or staining. Heavy rust accumulation.

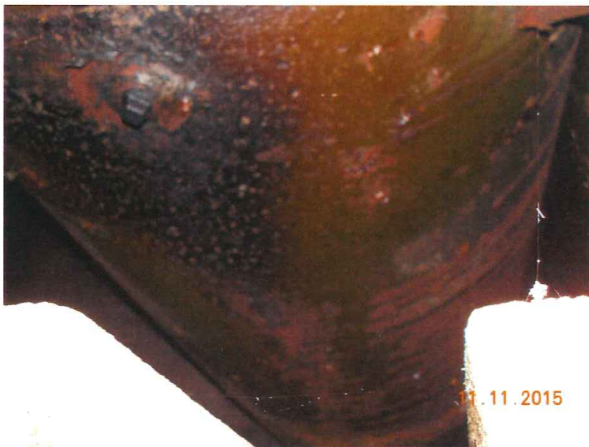
Underside of left AST (located on left side in photograph directly above).

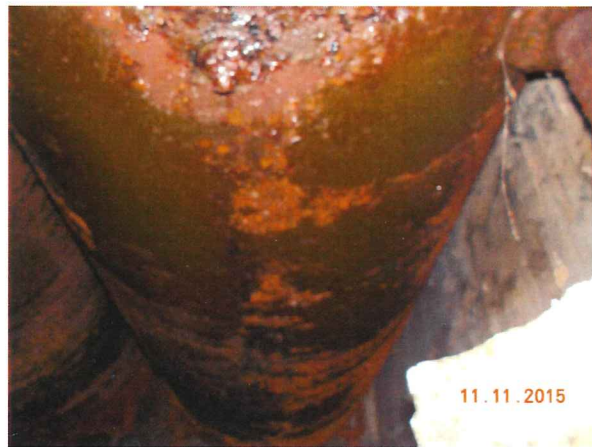
Underside of right AST (located on right side in photograph above to the left).

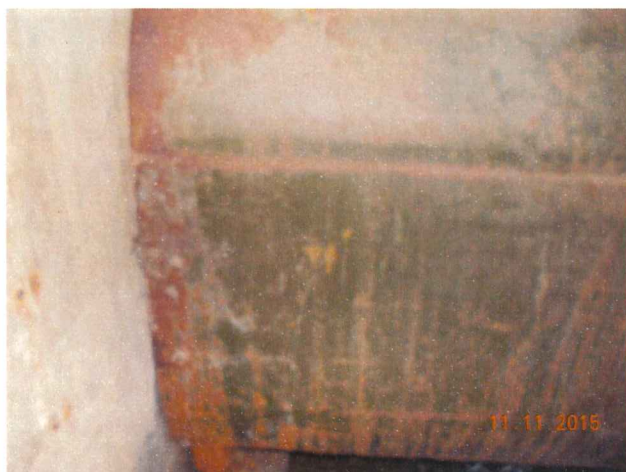
"Left side" AST sidewall condition. No structural damage.

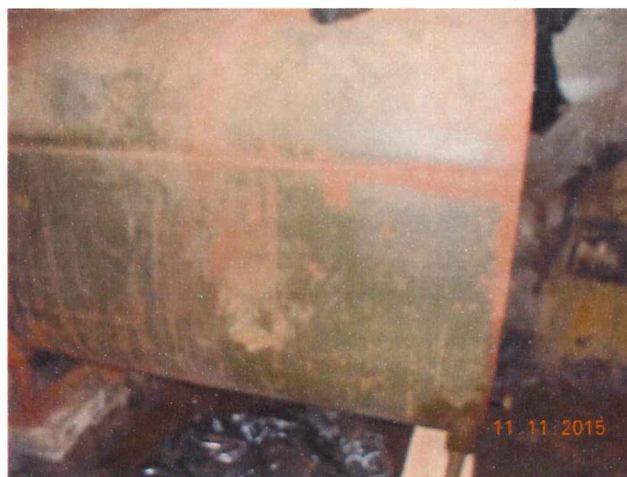
"Left side" AST sidewall condition.

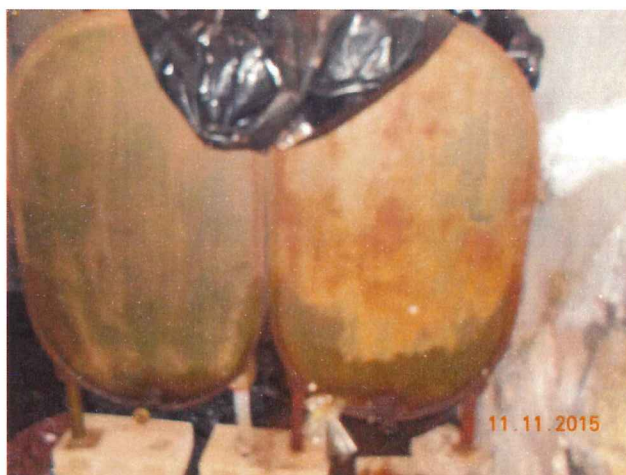
Front side of ASTs. No structural damage.

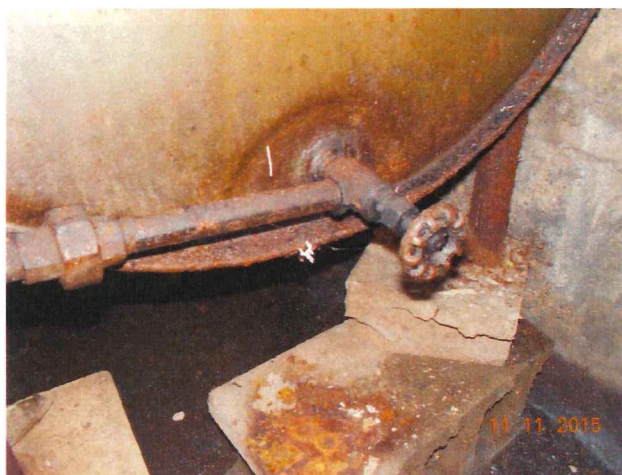
Front side of right AST and spigot. No structural damage.  
Rust water staining on cinder block.

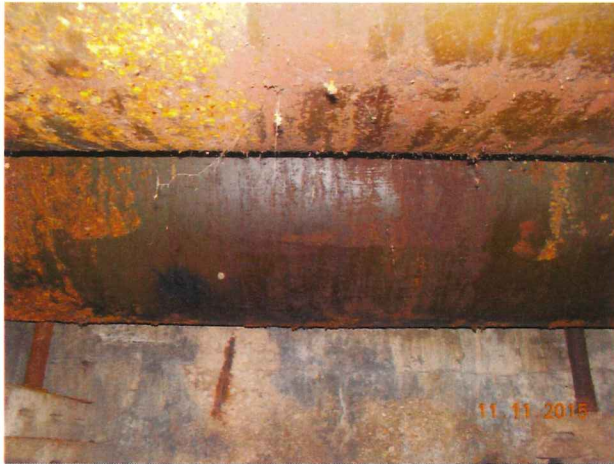
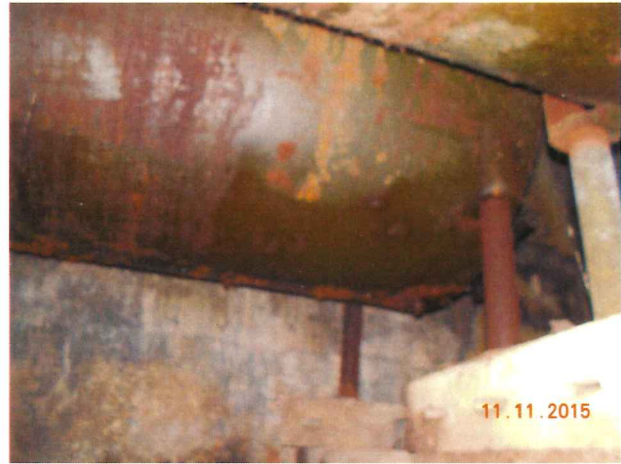
Additional photographs of underside of ASTs. Significant rusting however no evident damage or holes.

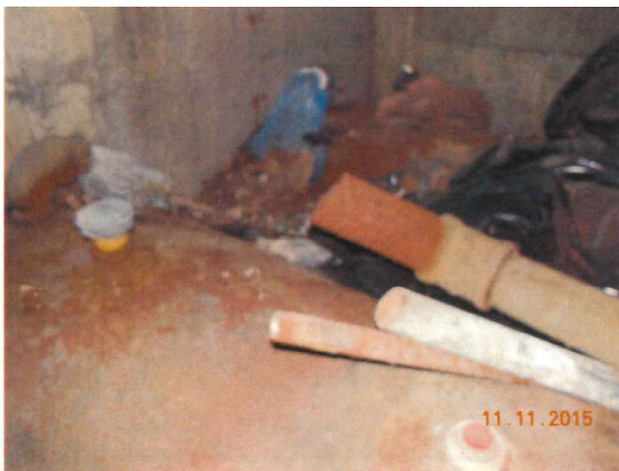
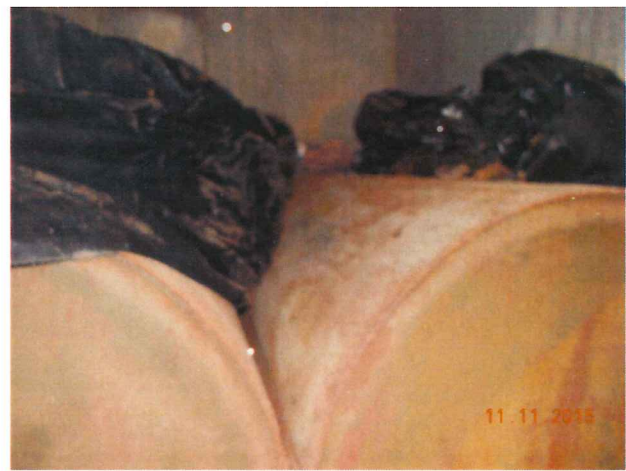
Top of AST conditions. All piping conduits dismantled. Again, no evident damage or obvious holes.
