November 13, 2015

Project Reference #15737-002

Re: Summary of Aboveground Storage Tank (ASTs) Release Evaluation Activities  
For the Former Messner Building  
1326 East Washington Avenue, Madison, Wisconsin

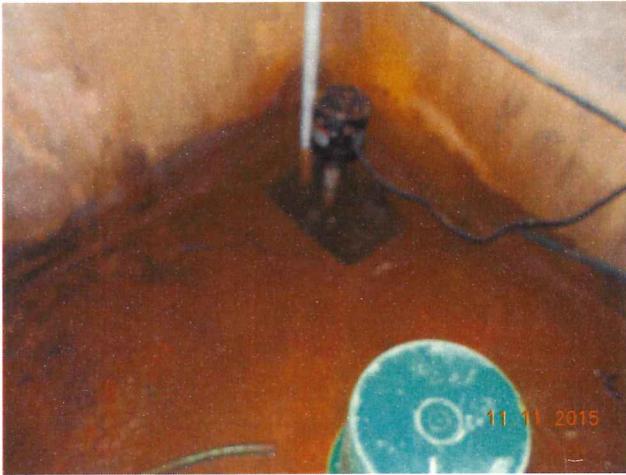
Stagnant water within basement and existing sump pump condition. Pump works, but requires manual activation as the sump ballcock is not attached.

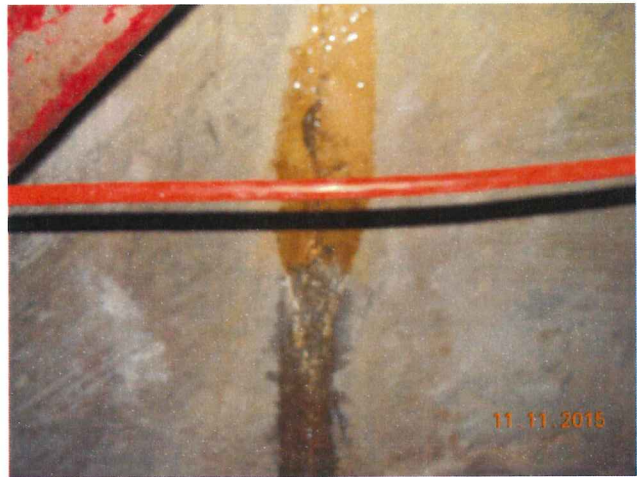
Fracture in right wall of basement stairwell. Apparent leak and infiltration of sump pump water through wall crack. Leaking water re-enters basement down basement stairs.

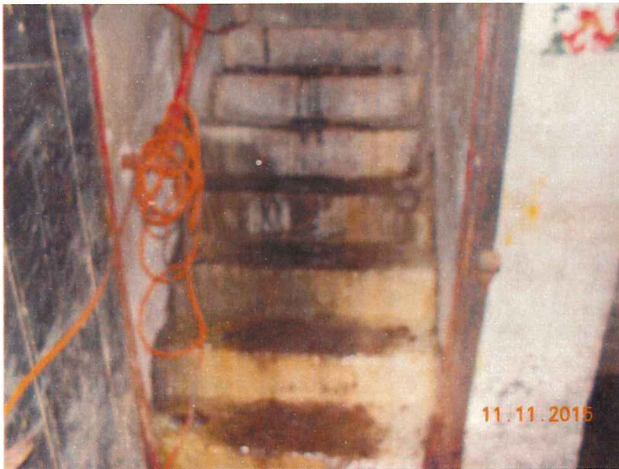
Leaking water coming down stairwell in basement. Salt and grime buildup.

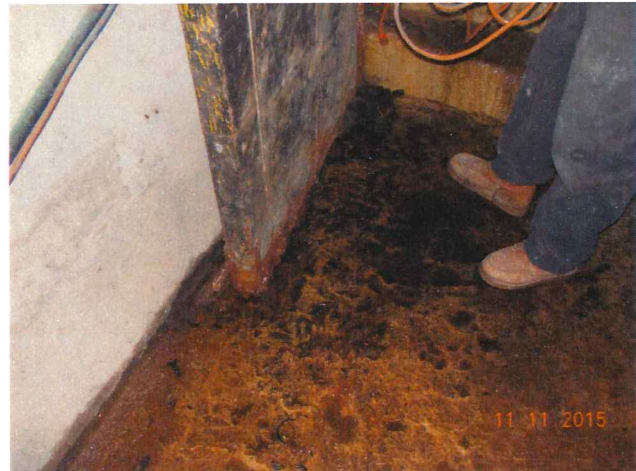
Water collection point at base of stairs. Drains toward sump pit.

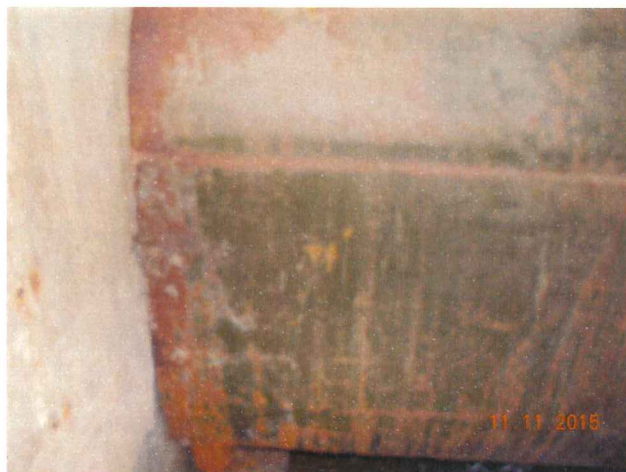
that would indicate the potential for inner contents to release to the surrounding room and/or environment. Strong oxidation/corrosion of the iron shell of each AST was apparent by the heavy rust which has developed on each tank. Rust and rust stains were present on the floor beneath each tank. Overall, the observed structural integrity of each tank was fair and no signs of a release were evident. Furthermore, no floor stains or sheen on the standing water beneath either tank indicated a recent or past release.

"Left side" AST sidewall condition. No structural damage.

- As appropriate, the ASTs should be properly abandoned and removed in accordance with all applicable local, state, and federal regulations.

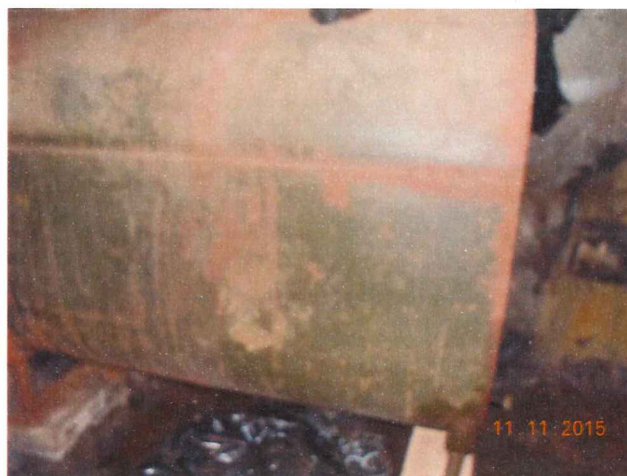
"Left side" AST sidewall condition.

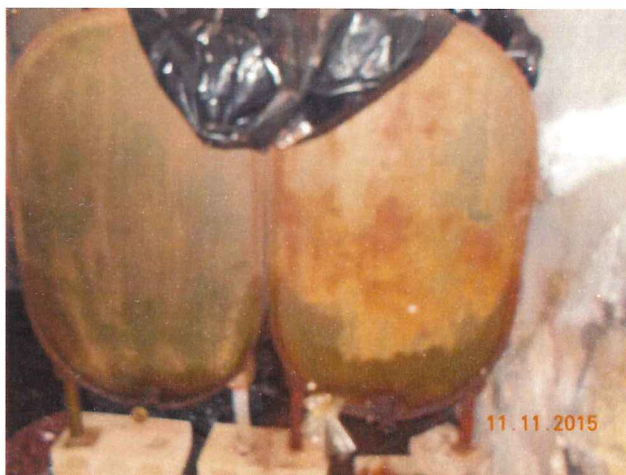
Front side of ASTs. No structural damage.

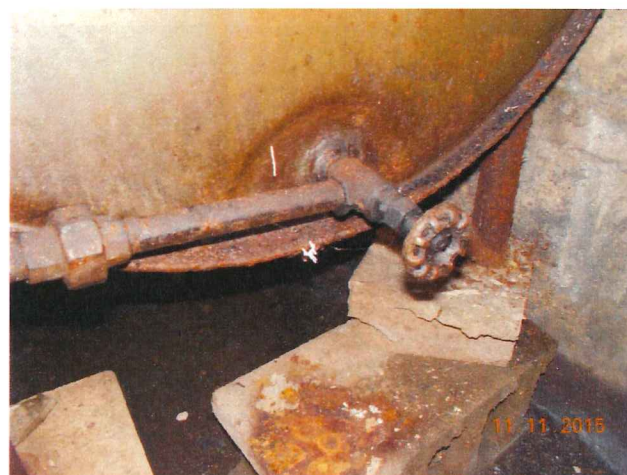
Front side of right AST and spigot. No structural damage.  
Rust water staining on cinder block.
